Loader bush and pin overhaul:

## It looks simple in the video, but in practice...

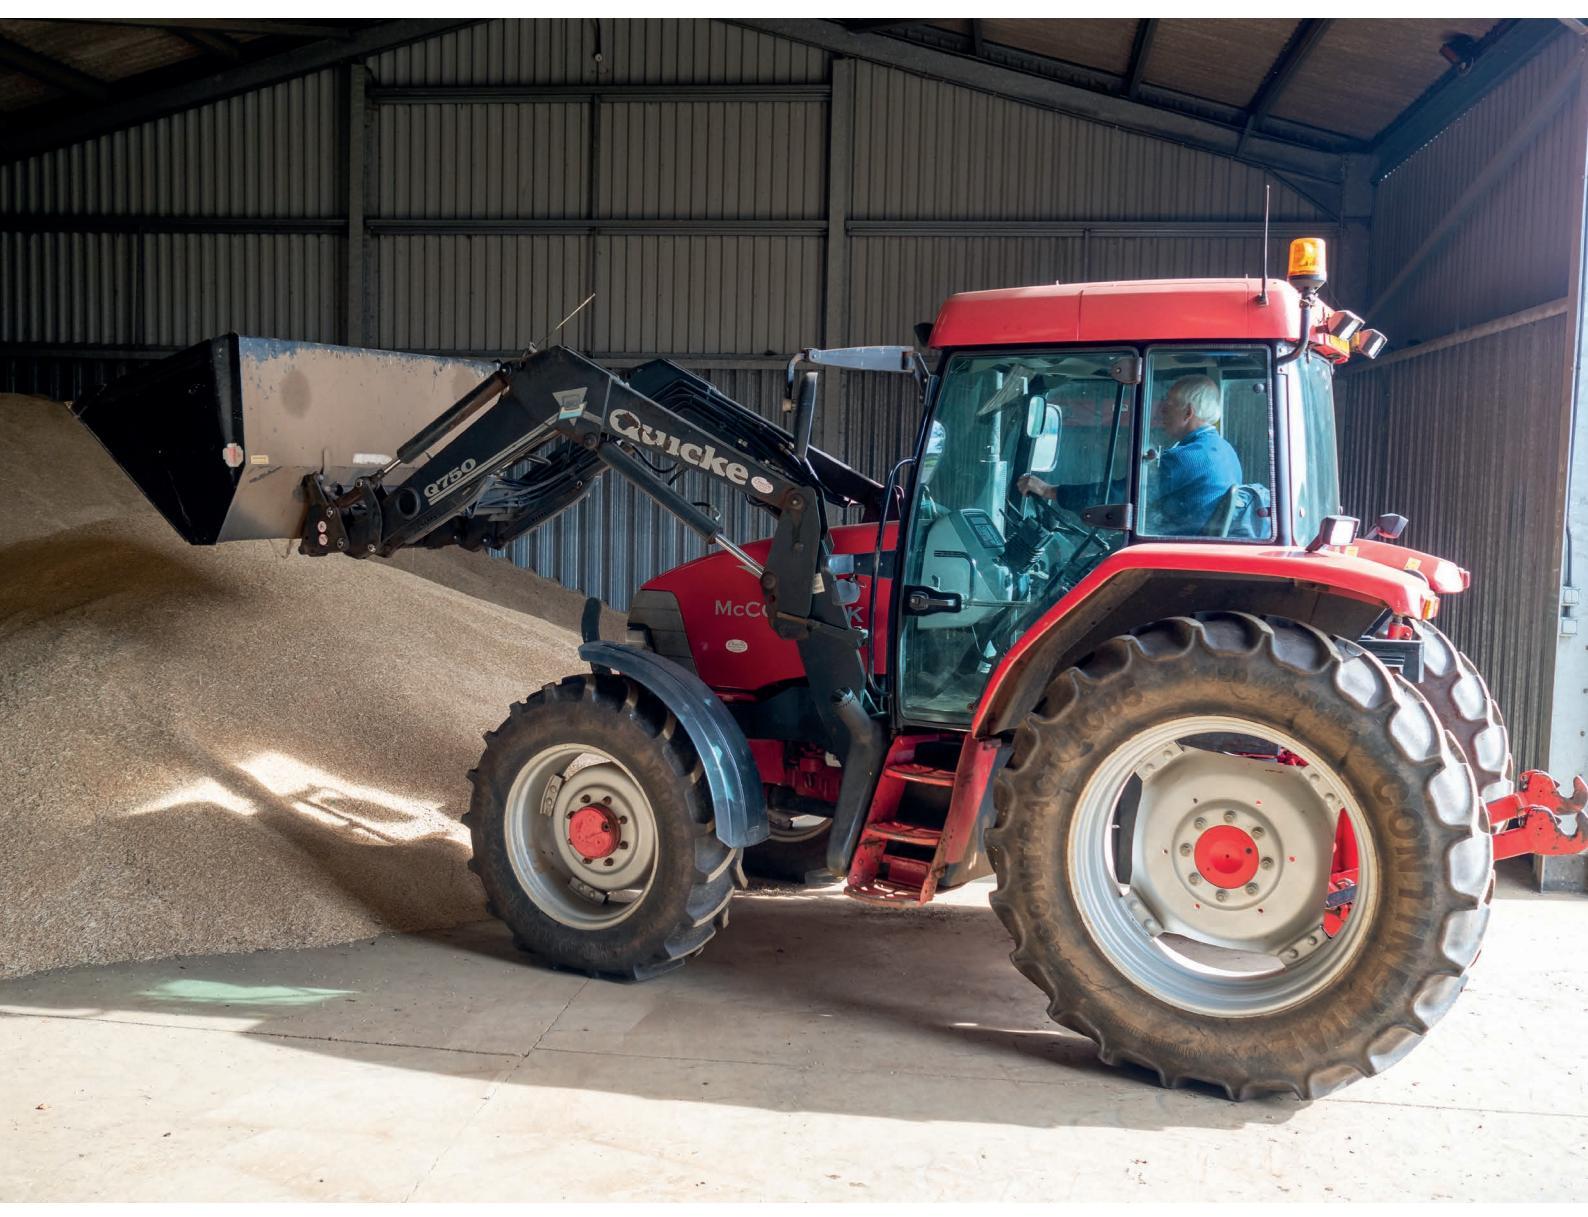
The pivots and bushes on a front-end loader are subject to wear, with those at the carriage end typically working the hardest. The subject Quicke Q750 loader and the now 6,500hour tractor have been together since new in 2005, the loader having seen routine attention from a grease gun but little else.

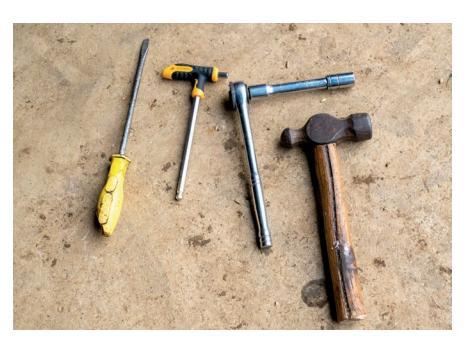
Basic pin and bush replacement tools should include an old flat head screwdriver, heavy hammer and a socket to undo the bolt-on locking covers and an Allen key to fit the new replacements. We found a drift and smaller screwdriver also came in handy.

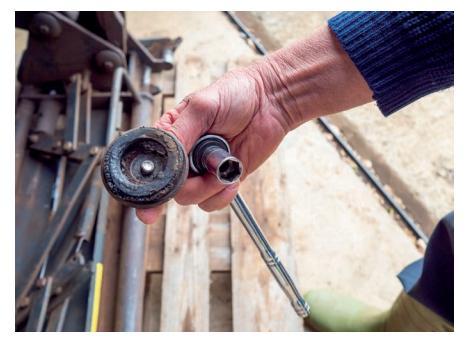
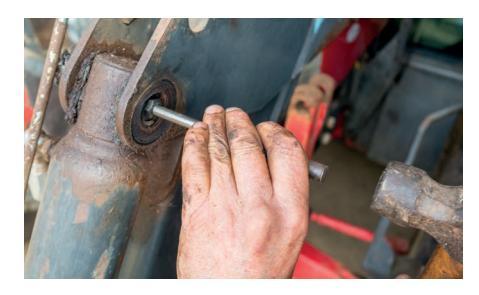
We decided to work on initially just the carriage, tilting it fully flat and resting it on a pallet for removal. This made it easy to access to all the bushes. The original metal capped locking covers unbolt from the pin to allow it to be pushed out...

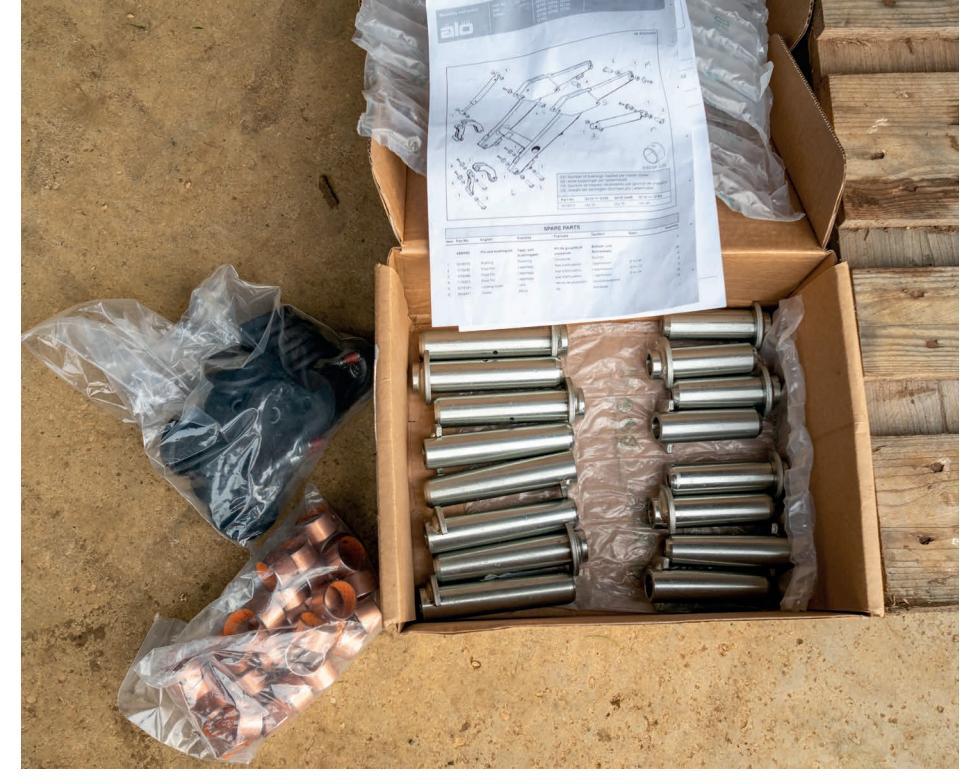
Quicke supplied a pin, bush and locking cover kit to renew all the pivot points on the loader. For instruction on how to do the job, the company will refer you to on-line videos.

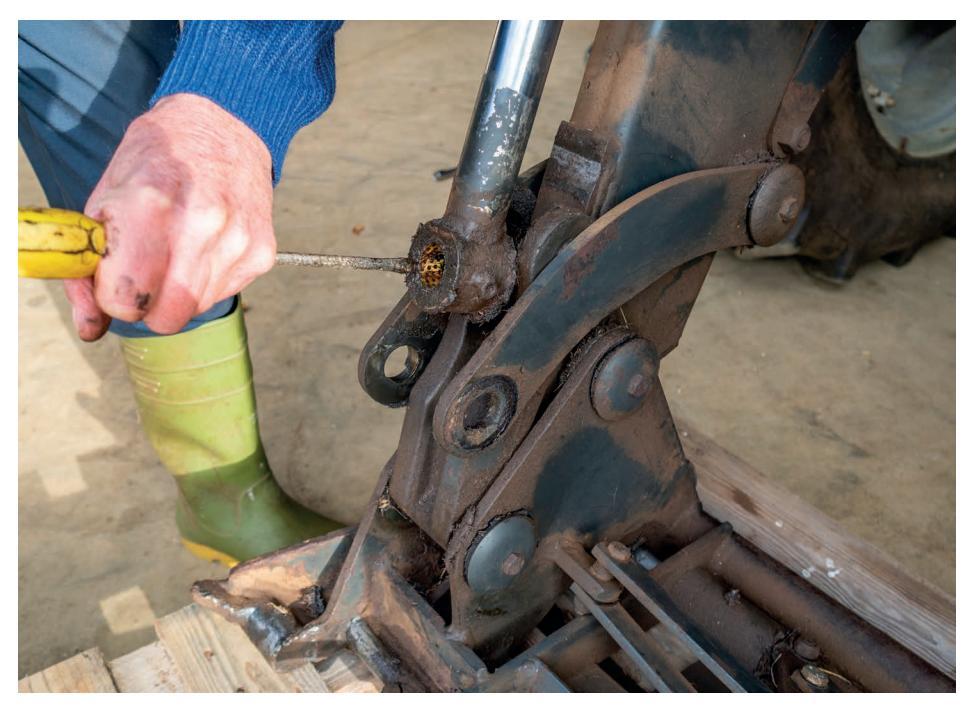
The tilt ram pins and bushes looked barely worn although there was a degree of play in the pivots. Removing a lightly worn bush was easy once we got the knack ...

In the video, a flathead screwdriver is used to part the 'worn' bush from its housing, simply levering it out to pop the bush free. This approach worked well with a bush that was not over worn as you can easily see the line that separates bush and the parent metal and force the screwdriver between the two. With a severely worn bush, we found it hard to determine the edge of the bush and, with a really worn bush, see if a bush was still insitu. We just felt for an edge where we expected the remnants of the bush to be and resorted to using a small screwdriver to work between the bush and its housing.

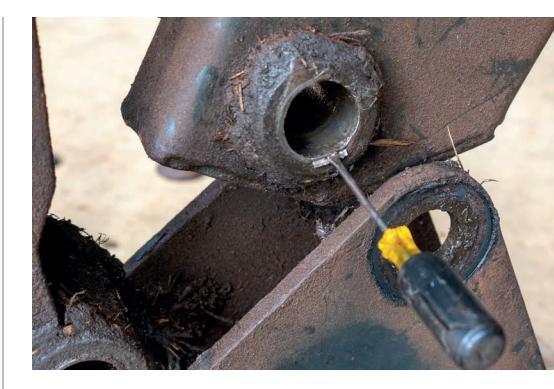
...unlike the really worn bushes at the base of loader arm. These were worn paper thin, with the lip proving hard to see. The bush was prized out with the aid a small screwdriver.

NOTE: We found the remains of a really worn bush still in-situ, despite it looking as if the housing was bare parent metal with no trace of the original bush. If a bush is reluctant to be tapped into place, ensure the housing is completely clear of all traces of the old bush.

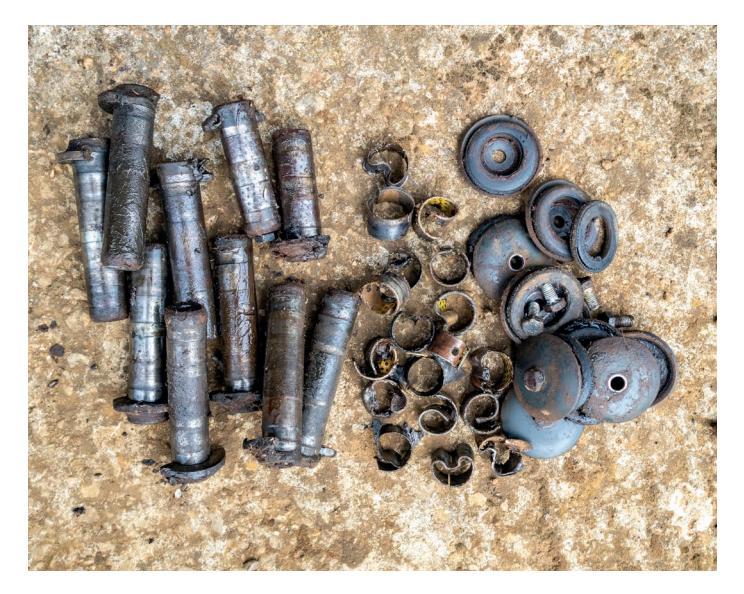
Wear in the pins and bushes was not evenly distributed, with a couple of the replaced items showing virtually no wear with others quite the opposite. No surprise that the latter were at the lowest point of the carriage.

Once the bush has been seated on one side, the pin will need removing so it can be used to secure the opposite bush. We damaged the locking cover bolt hole with the drift on one pin, screwing in a bolt into the thread ensuring this did not happen again.

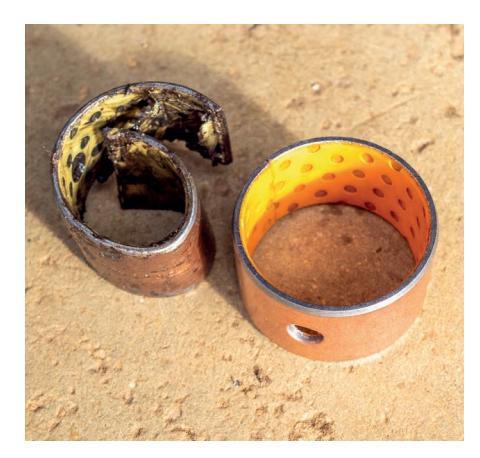
Removed bush on the right looked, like its corresponding pin, to be barely worn....

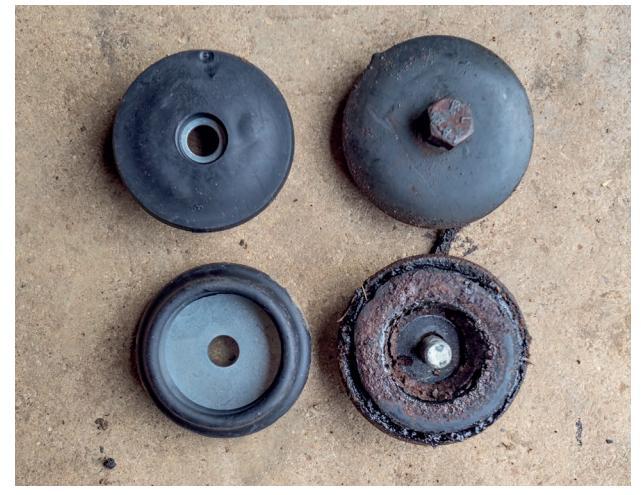
RIGHT: ...the two lowest carriage pins running in paper thin bushes that proved difficult to remove. One of the pins was 'dry', its refusal to take grease having long provided a clue that it needed some attention.We then added another shot or two.

wear in the carriage bushes and pins. A couple were renewed just in time, with paper thin bushes and wear grooves in the pins suggesting we caught them before they would soon start to eat into parent metal. You also need to be careful when visually looking at a pin or bush to check for wear. The upper pivot of the tilt ram had a slight amount of play but pins and bushes looked as good as new. When these pins and bushes were removed, however, it was easier to see that they were worn evenly all round and this made it hard to pick up what must have been a fair degree of the wear. New pins and bushes removed all traces of play. The design of locking covers in the parts kit (left) differed from the originals but proved a perfect fit...

...with Allen head fasteners in place of the bolts. The threads of the new screws have a thread lock coating to prevent them working loose.
